Colby Fire Trail Survey BAER Report

Garcia Trail

January 27, 2014

by Freddie W. Duncan

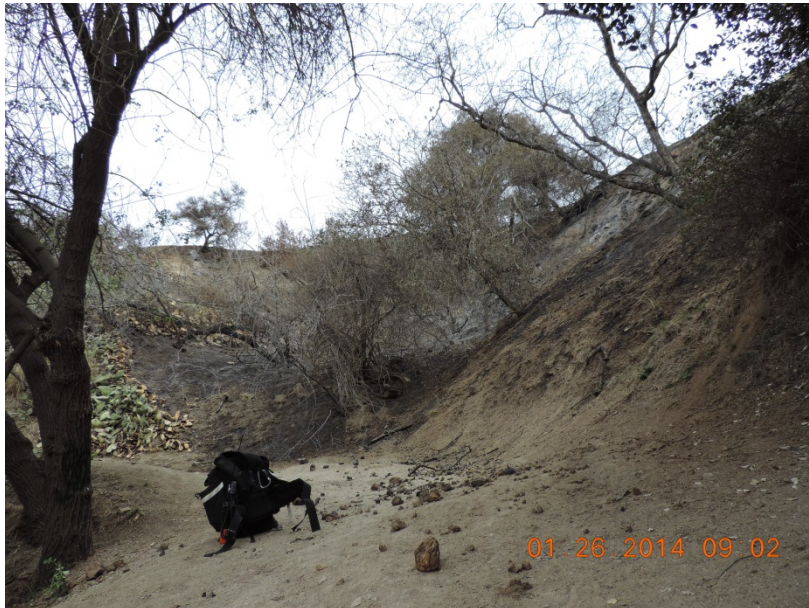
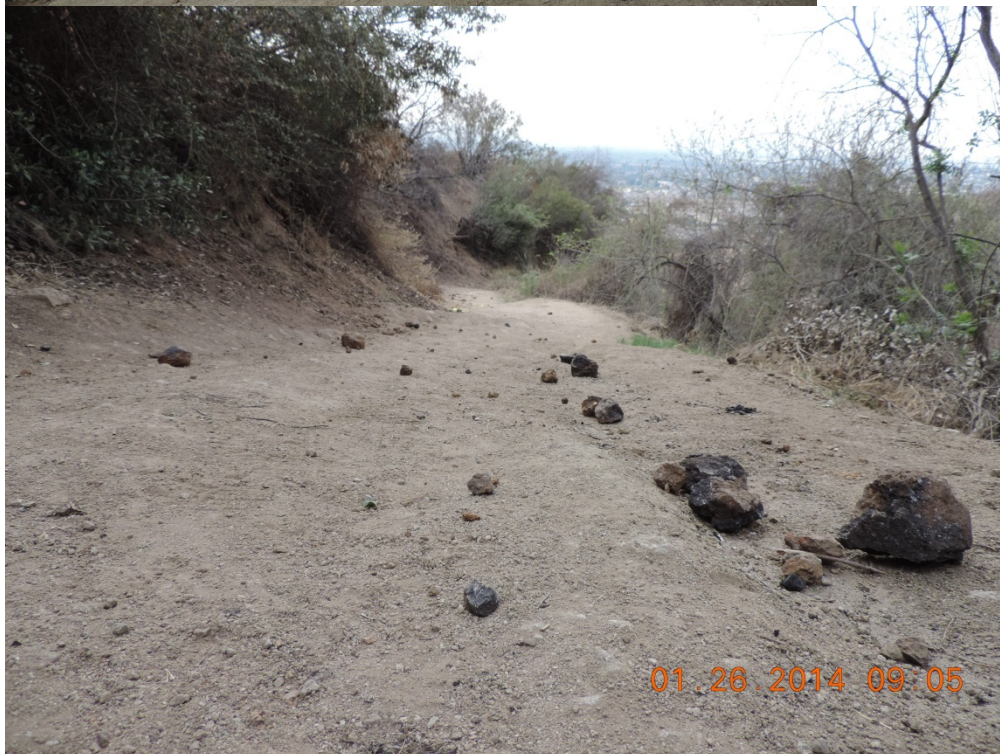
Site 1 Location 34.148698 , -117.889901

This drainage transects the trail three times. Trail tread aligned with drainage.

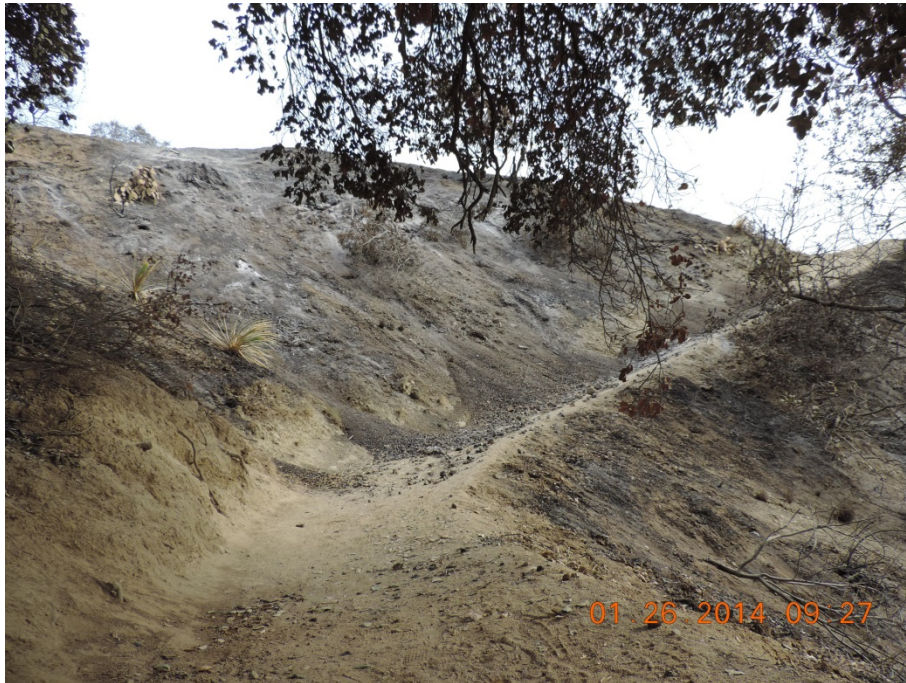
Site 2 Location 34.149217 , -117.889205

Poor drainage design coupled with unstable soil above trail tread.

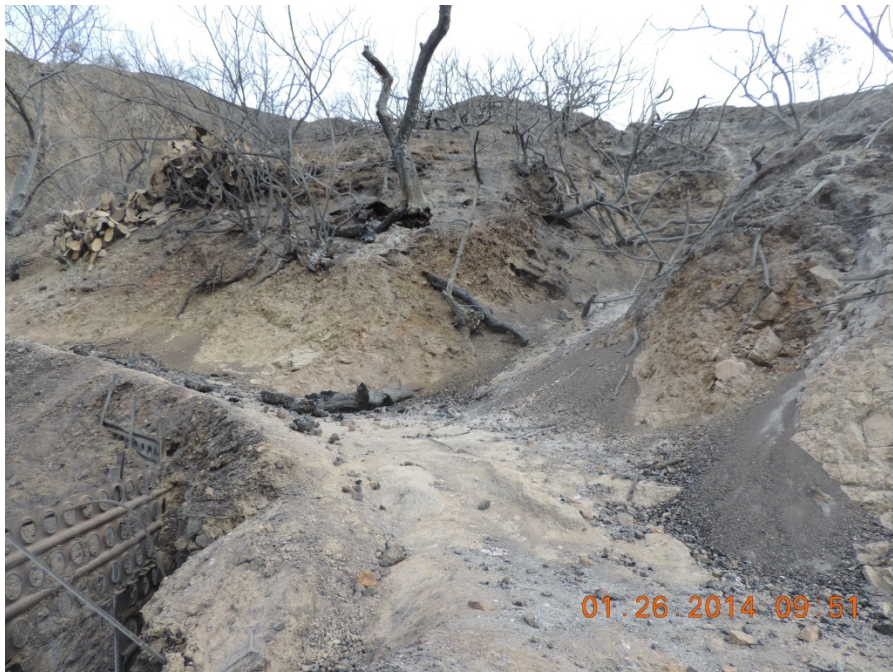
Site 3 Location 34.150857 , -117.888344

Drainage aligned with radius turn on trail tread.

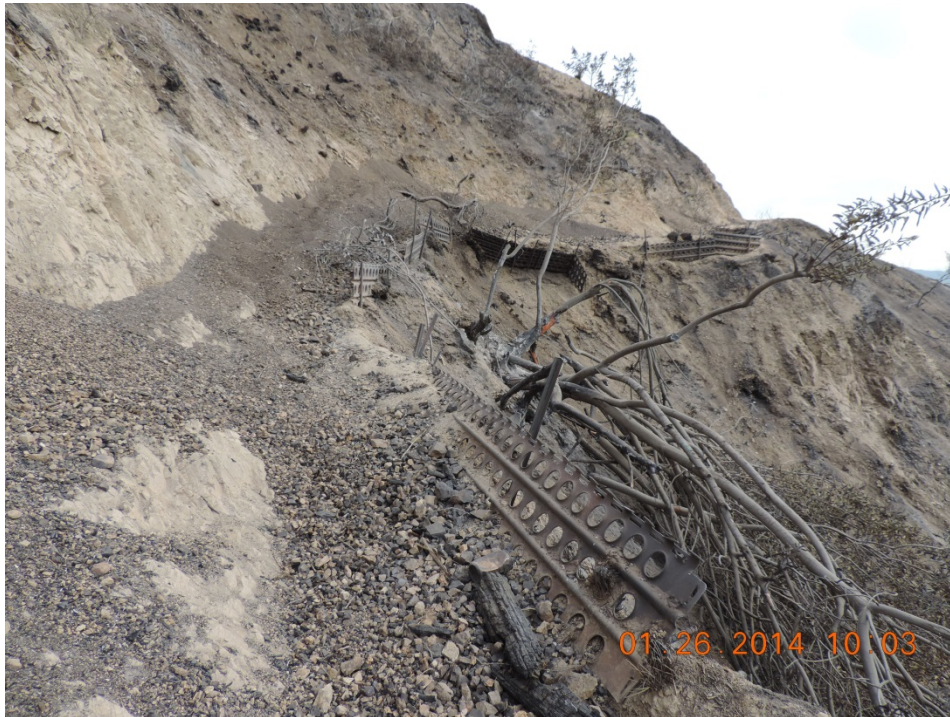
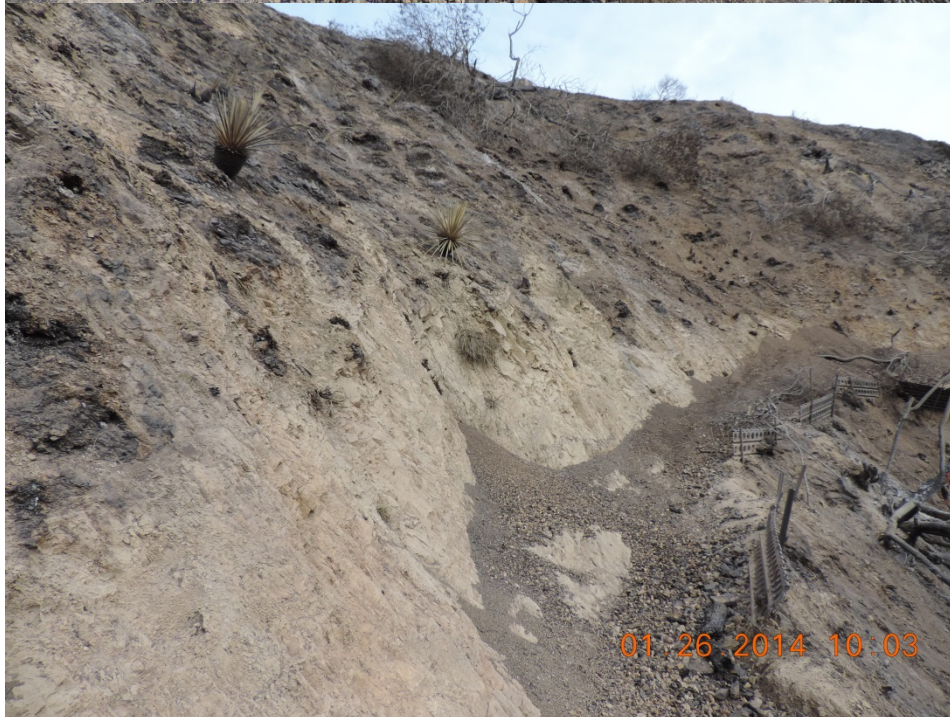
Site 4 Location 34.151192 , -117.887691

An estimated 60 percent of the trail tread has been covered by dry ravel as a result of the Colby fire. Ninety percent of the retaining walls which once supported the trail (Site 4) are failing and in a state of disrepair. Unconsolidated loose materials continue to erode downhill covering the trail tread even under stable weather conditions. Ten to fifteen percent of the Garcia trail treads runs perpendicular to contour in alignment with drainages that may experience heavy run-off during precipitation.

Failing retaining wall system.

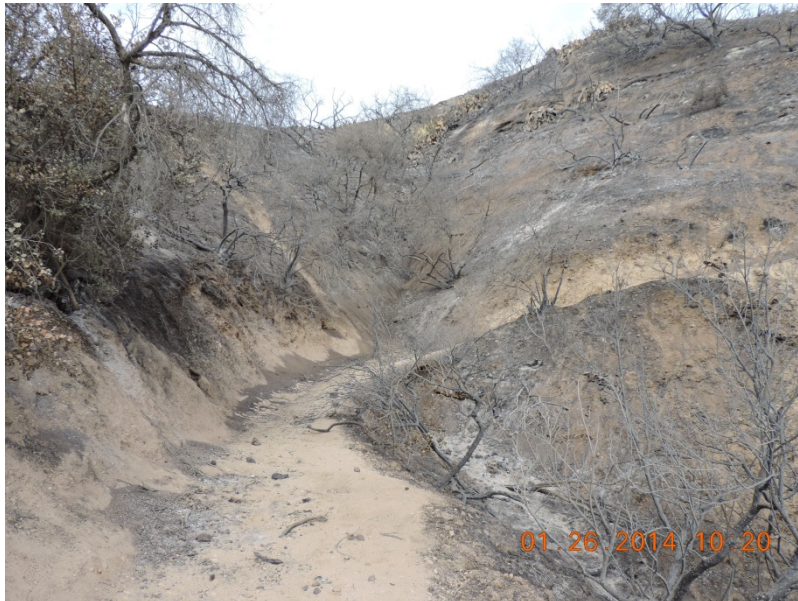
Site 5 Location 34.15161 , -117.88756

Drainage aligned with radius turn.

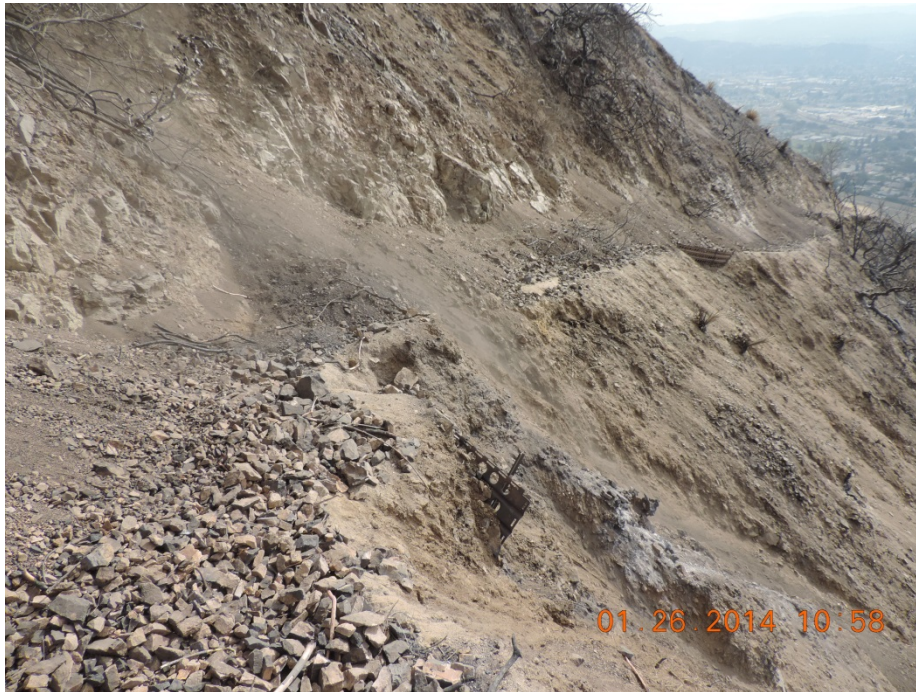
Section 7 Location 34.15391 , -117.888364

Trail tread covered with dry ravel, failing retaining wall.

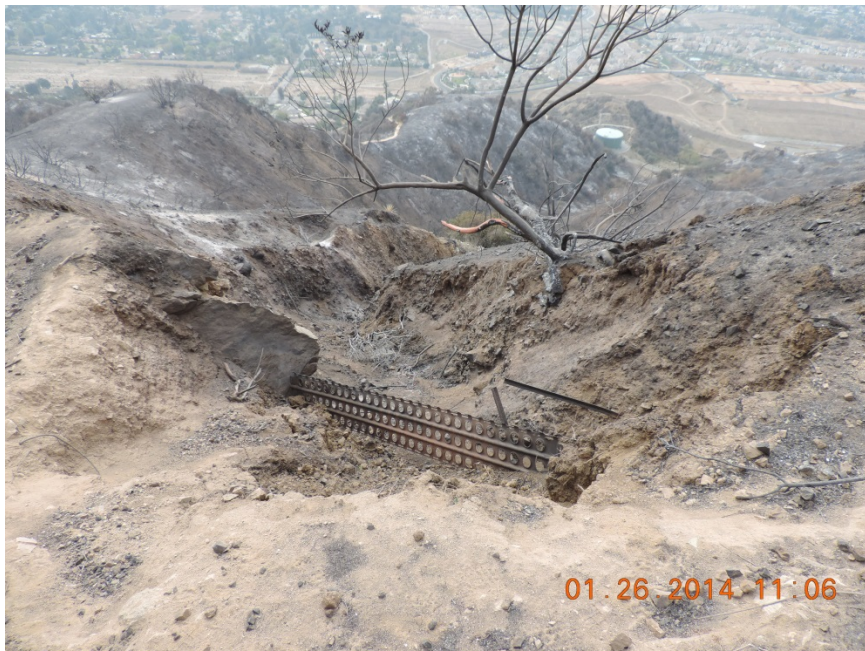
Section 8 Location 34.153991 , -117.888752

Drainage intersecting trail tread. Failing retaining wall.

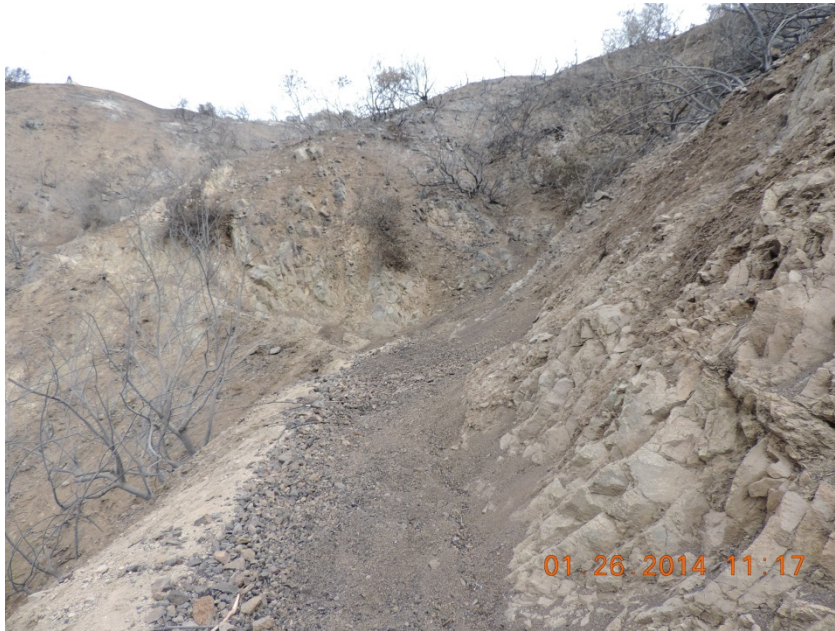
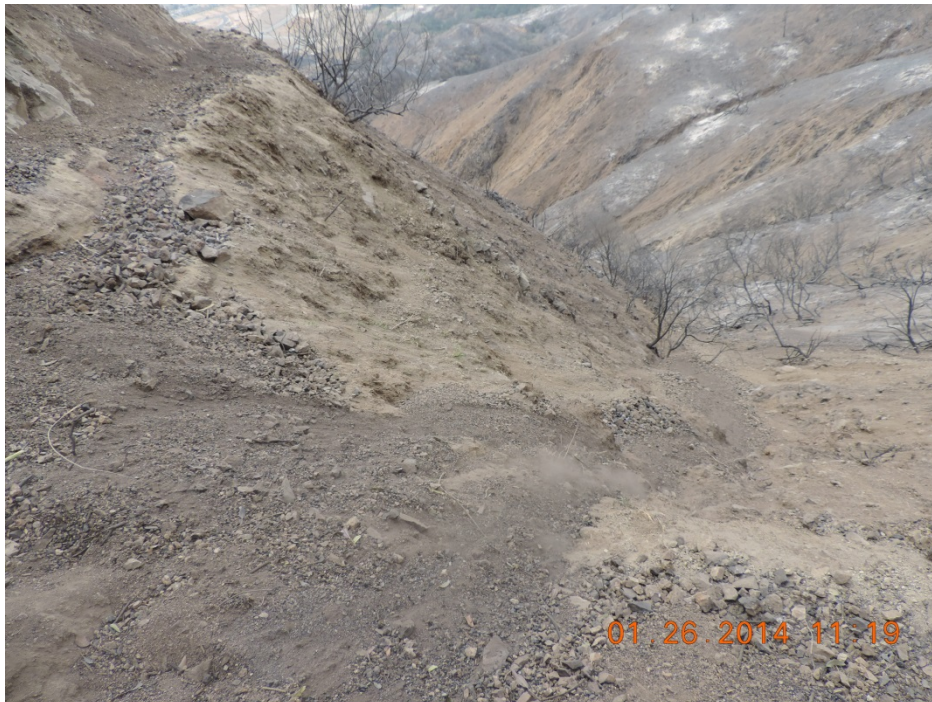
Site 9 Location 34.15005 , -117.889944

100 percent slope with dry ravel covering trail tread under stable weather conditions.
